Portage Creek Sediment Remediation Project Kalamazoo, Michigan

Post-Sediment Removal Structure Feature Assessment Removal Area SA3-A

F&V Project Number: 809930
August, 2013

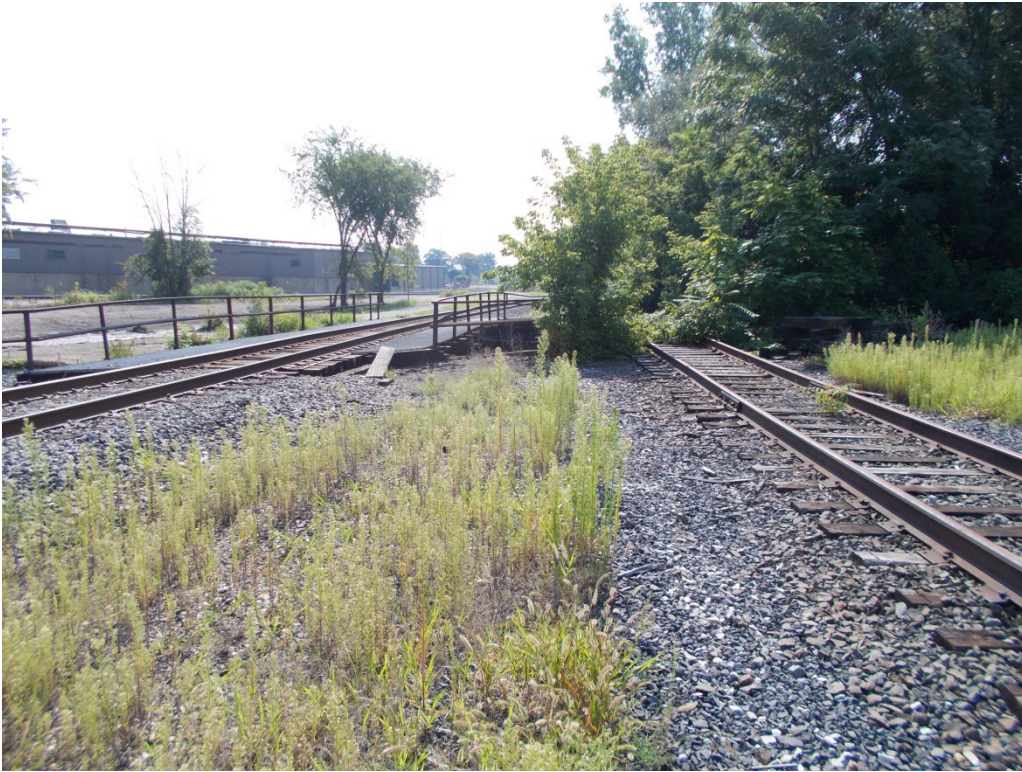
- The failed conduit along the north side of the structure appears to be unchanged.
- The structure does not appear to have been impacted during sediment removal.

Structure viewed from track level

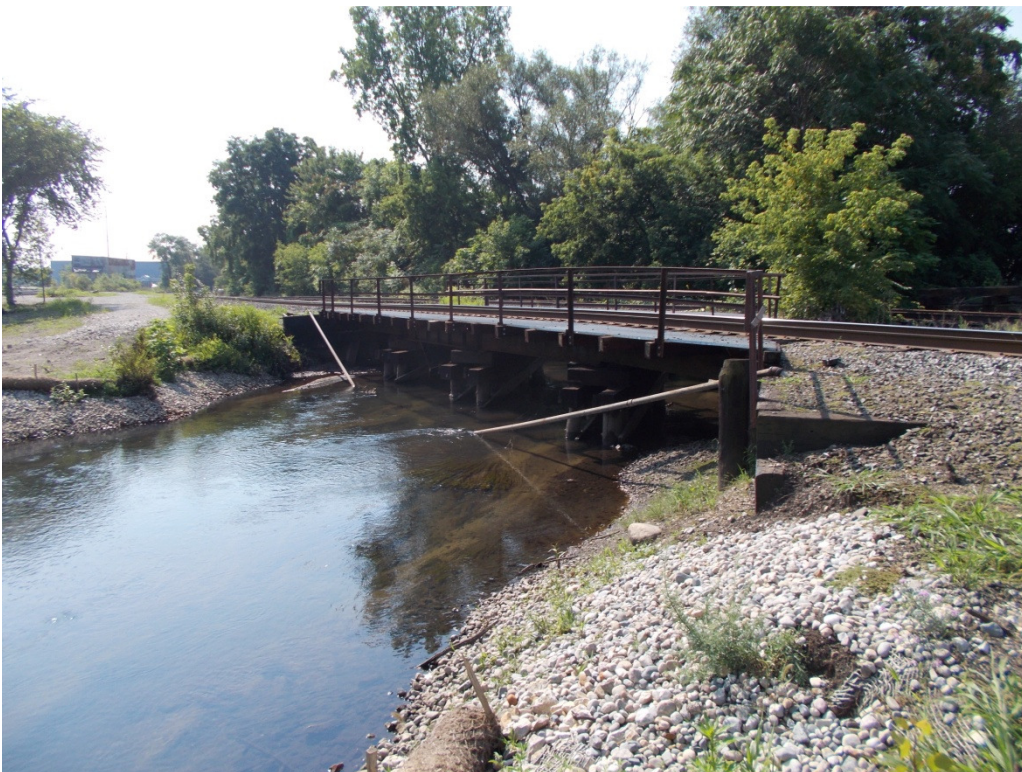
Elevation view of the structure

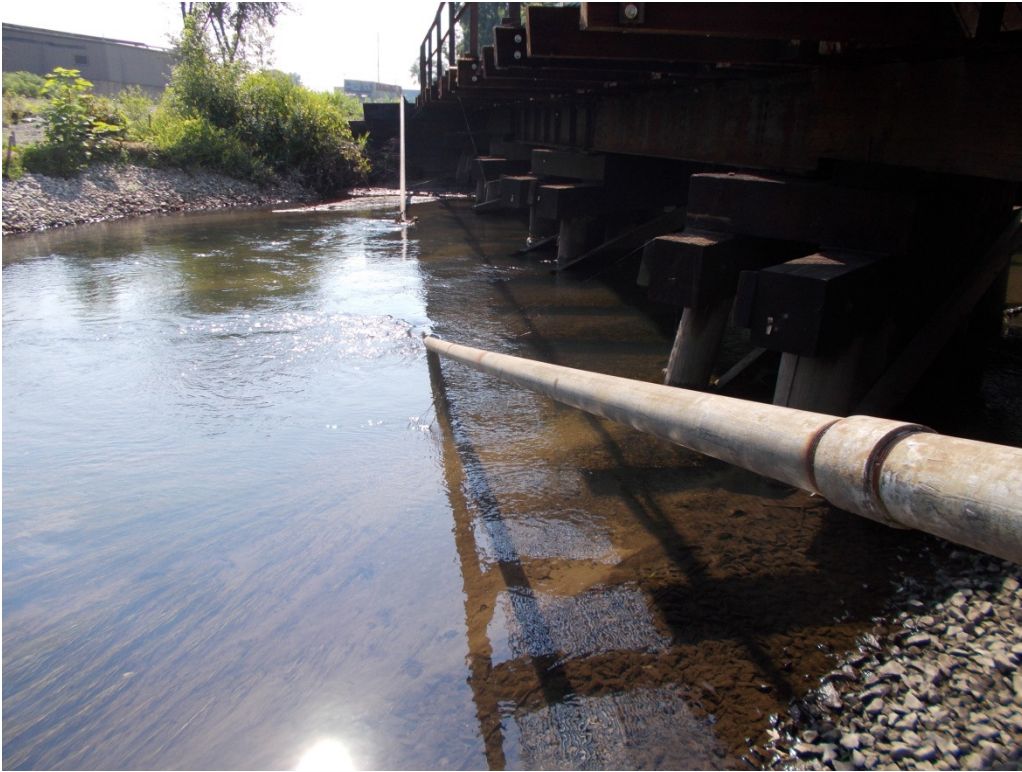
View of the failed conduit on the north side of the structure

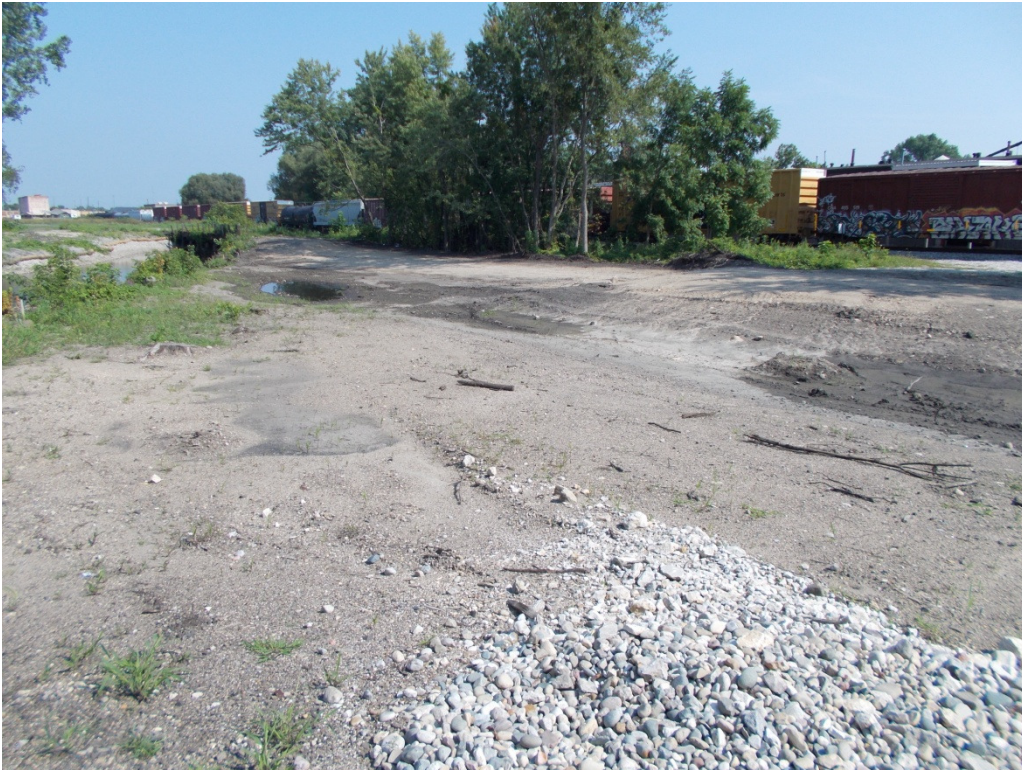
- The area has been cleared and the pole and guy removed.

View of previous pole and guy location

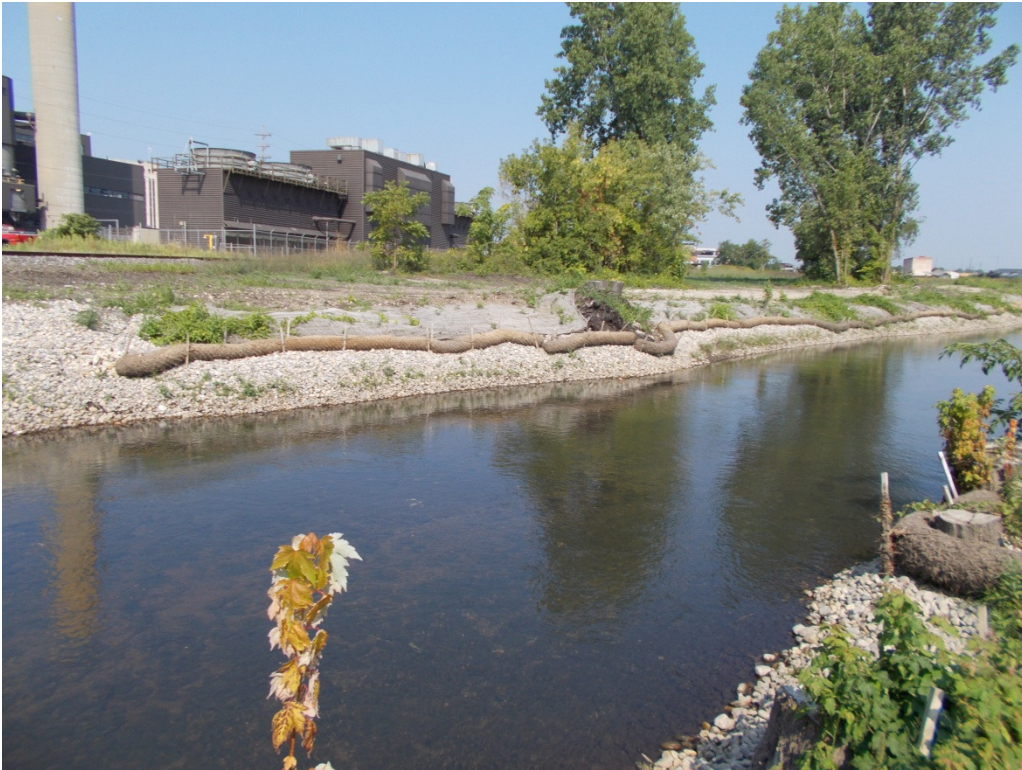
- The structure has been removed and bank restored.

View of the west bank in the area of the previous structure

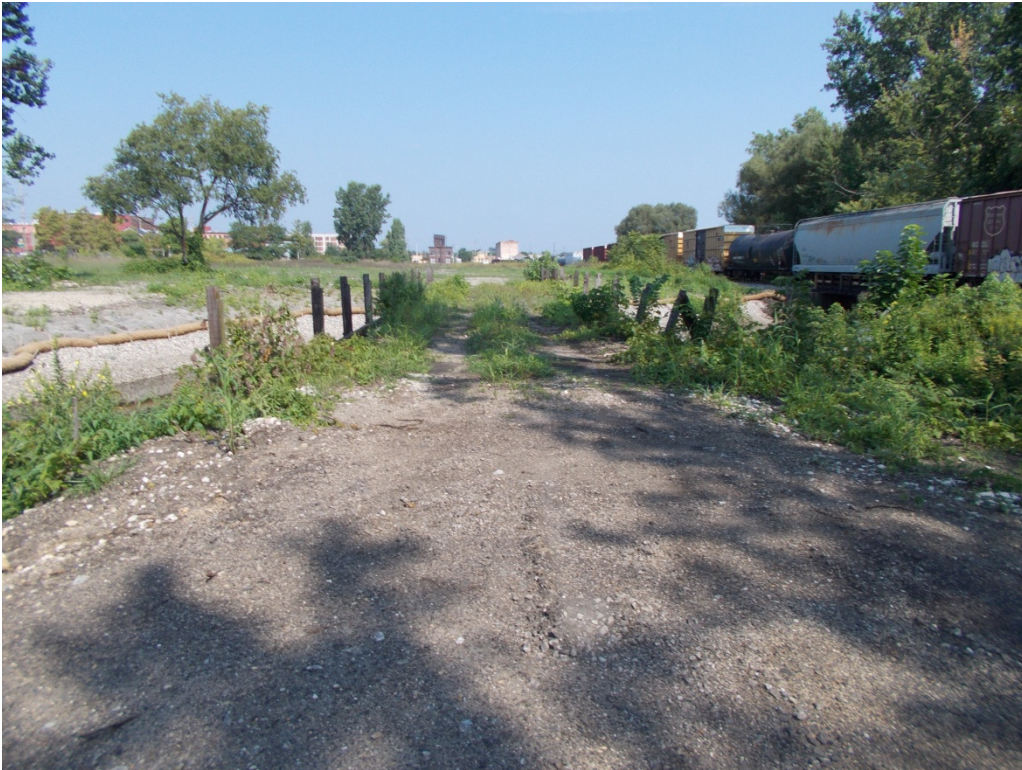
- Debris caught on the upstream side of the structure has been removed.
- The structure does not appear to have been impacted during sediment removal.

View of the structure looking north

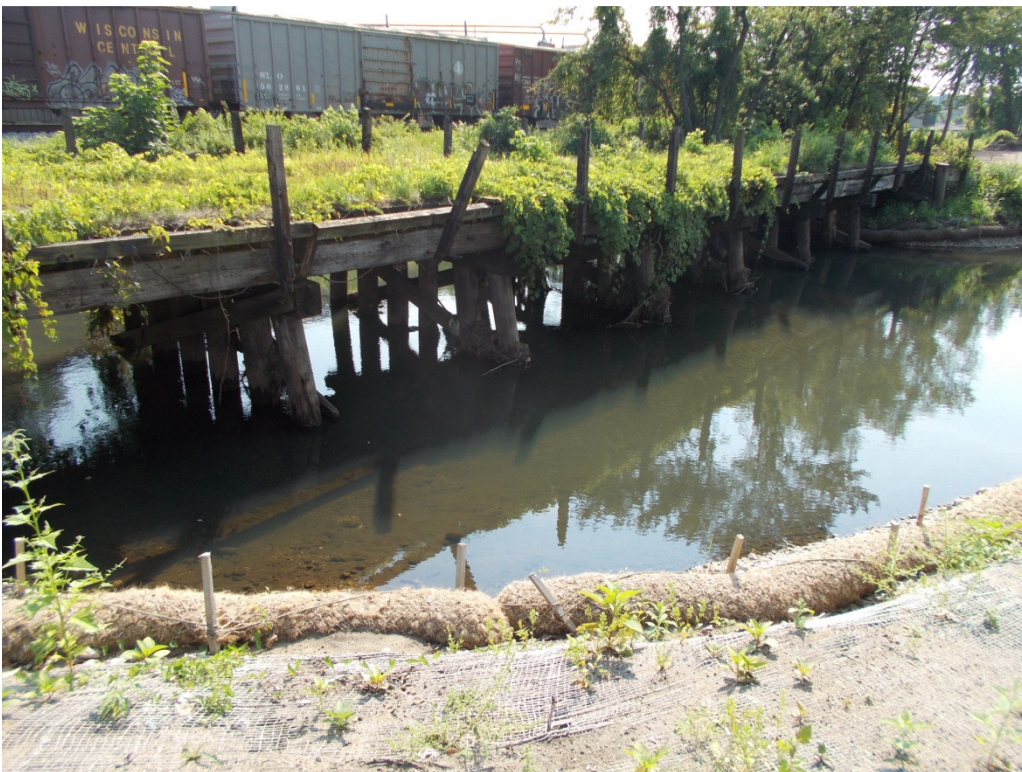
Elevation view of the structure from the west bank

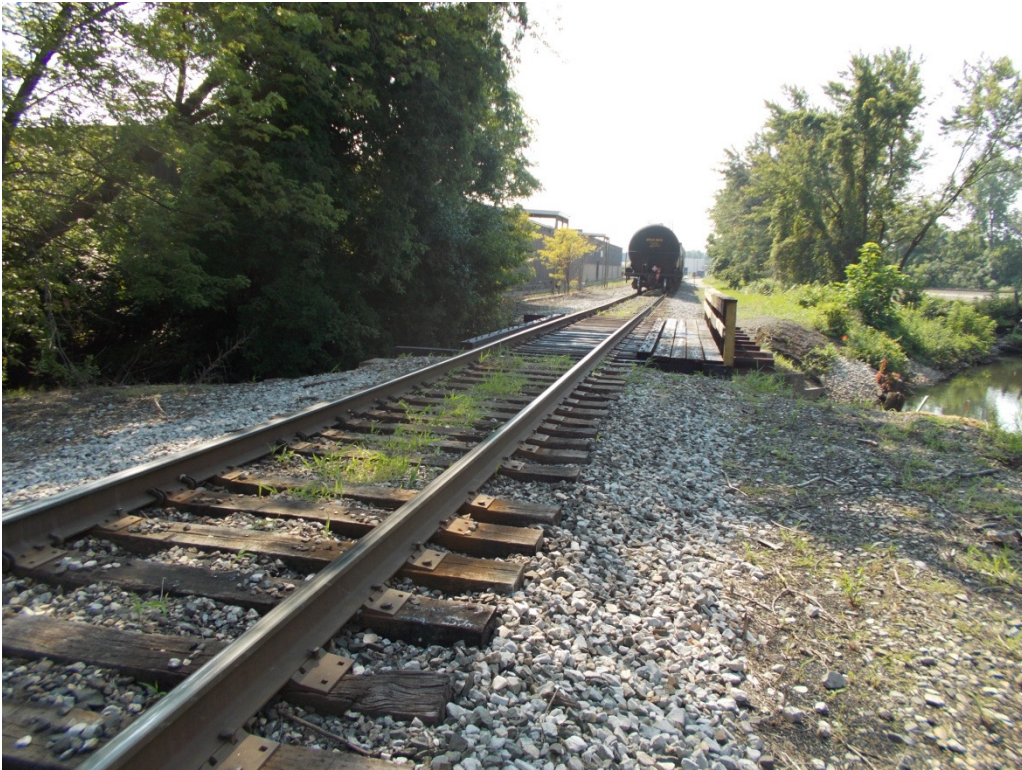
- The structure does not appear to have been impacted during sediment removal.

View of structure from approach track

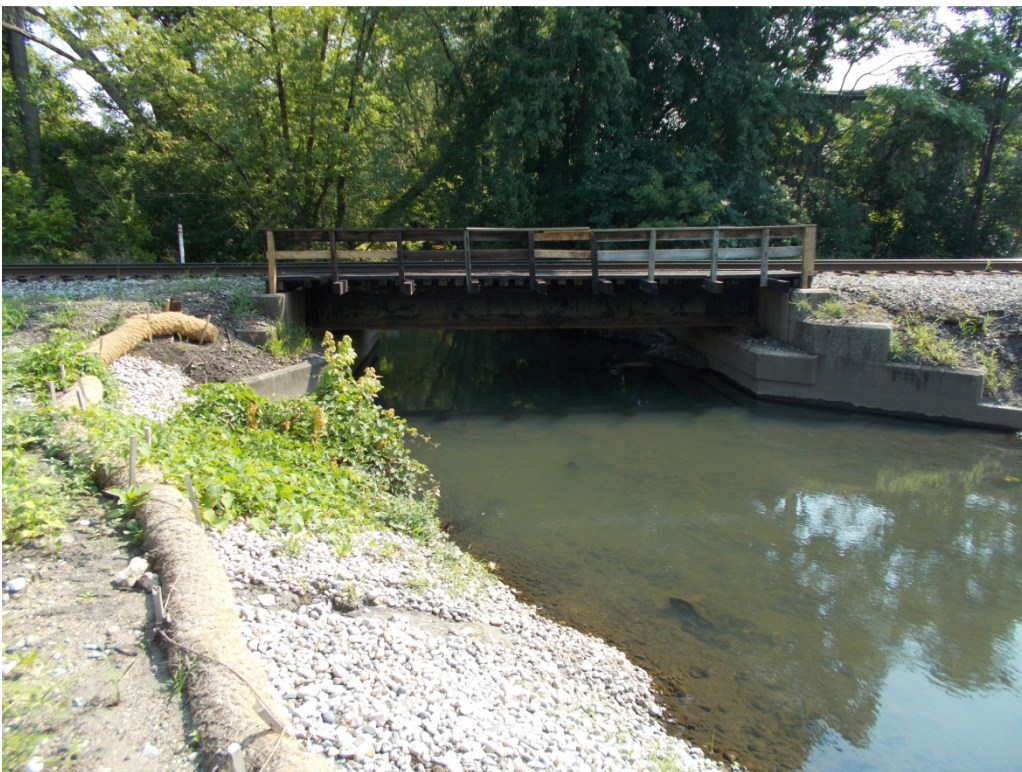
Elevation view of structure
